**STAFF REPORT 08-14-2019 REGULAR MEETING**  
**APPLICATION NUMBER:** 19-6371  
**ADDRESS:** 2444 SEMINOLE STREET  
**HISTORIC DISTRICT:** INDIAN VILLAGE  
**APPLICANT:** EMMALYN HELGE  
**STAFF SITE VISIT:** 08-02-2019

### **PROPOSAL**

With the current proposal, the applicant is seeking the Commission's approval **to remove the existing light tan paint from all brick and repaint with faux brick paint scheme per the attached application**. Included in the proposal are the following scope items:

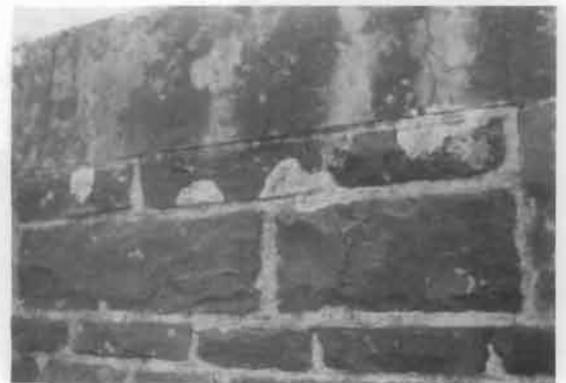
*Figure 20. Plant growth such as lichens growing on a protected side of this limestone and granite parapet wall, can be damaging even to a relatively hard stone like granite because lichens secrete oxalic acid. Lichens can usually be removed, after soaking with water by scrubbing with a stiff natural bristle brush.*

Lichens and algae can usually be removed with water and a stiff natural bristle brush, after soaking, if necessary (figure 20). Stains caused by plant growth such as mildew (which is a fungus) can sometimes be removed with organic solvents, but are generally best treated with diluted ammonia or bleaches. Hydrogen peroxide can also be effective. Calcium hypochlorite solutions and pastes (the basis of swimming pool chlorine) and Chloramine-T may also be useful in many cases. Chemical removal of the growth itself may sometimes be accomplished with zinc or magnesium fluorosilicate, copper naphthenate, or with a variety of quaternary ammonium salts. Low-to-medium-pressure (100-400 psi) water rinsing can be used to eliminate much of the plant material prior to treatment and stain removal. However, these compounds should be used with caution, as some copper compounds may stain light-colored

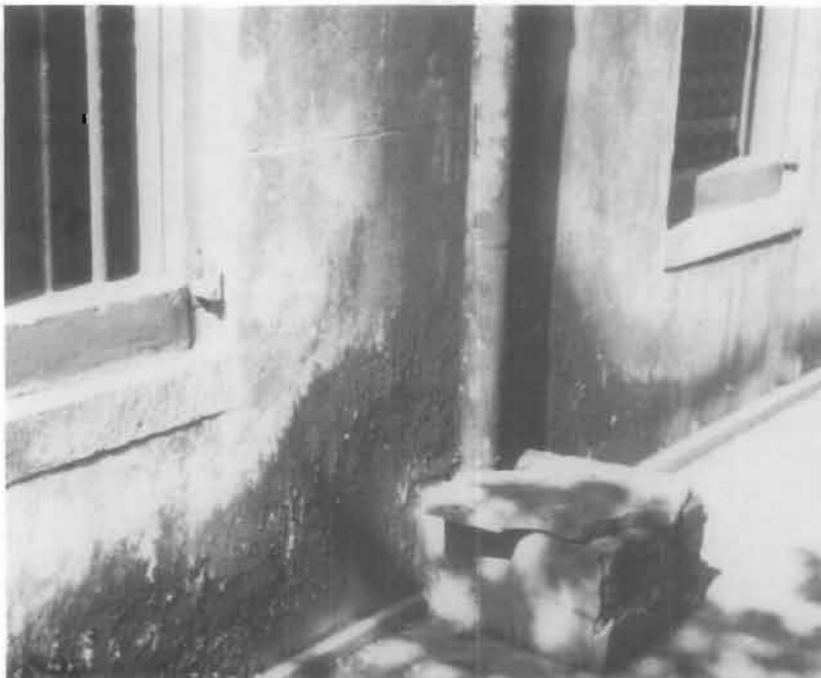
*Figure 23. The moss growing around the downspout and along the base of this stucco building clearly indicates the presence of excess moisture—here due to rising damp as well as a leaky downspout. Photograph: Lee H. Nelson, FAIA*

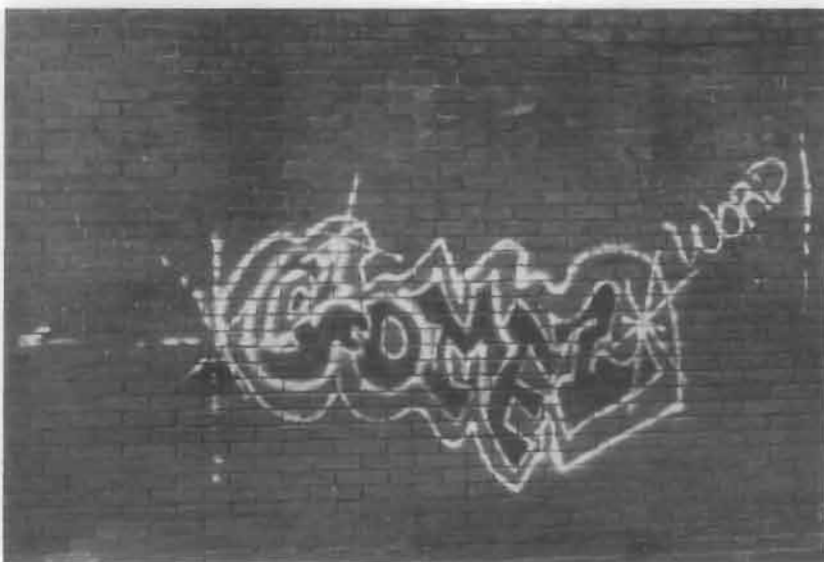
Figure 24. Spray-painted graffiti on this brick wall can be removed with paint remover, and in this case, probably will not require poulticing.

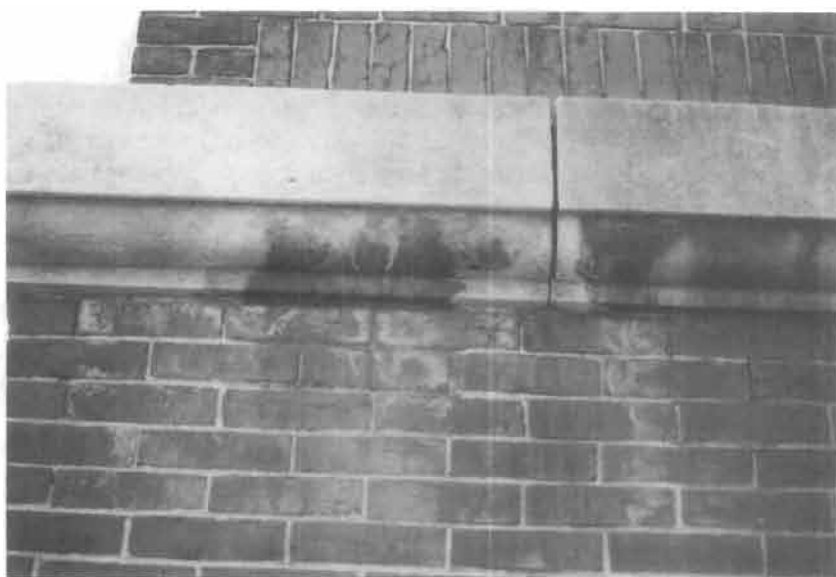
Figure 25. Excess moisture leaching out through the walls has resulted in the formation of white efflorescent salts on the brick and blackish sulfate salts on the limestone water table.
